Concertgebouw Amsterdam: History of the main hall and its acoustics

PART 1: The early years: acoustic design and resolution of acoustic difficulties

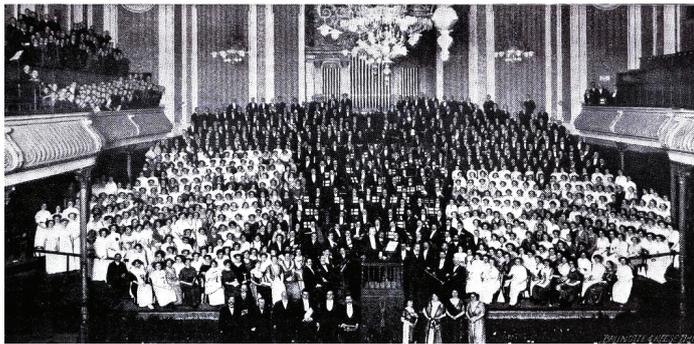
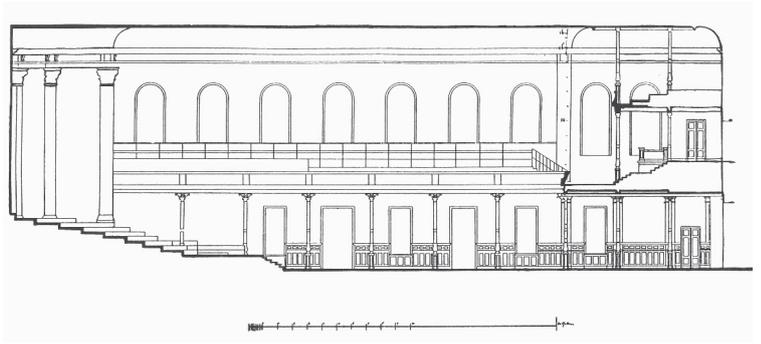
Figure 2. Tonhalle Düsseldorf: Kaisersaal. Left: Photo Mahler 8th Symphony, 1912, Right: section

However, in a later article in the *Algemeen Handelsblad* (March 1882) a well-known Rotterdam musician Mr. Thooft, who lived in Düsseldorf for five years, mentioned that there was a rather negative opinion of the acoustics of the Kaisersaal (3). According to Thooft, the acoustics was related to the shape of the plan; for a large hall the rectangle shape was considered dangerous because of the large distances between stage and audience. Especially for a large hall, the oval or circular shape should be preferred! Therefore, the board was confused. In the first presentation of the programme (June 1882) it stated the shape should be “rectangular, oval or circular”(!). In the second programme (July 1882), this was skipped and the shape was completely left to the architect. Also interesting in this period (June 1882) is the discussion on the slope of the audience area. The jury preferred a sloped floor to improve lines of sight but the board preferred a flat floor (to be able to accommodate diners, dancing etc). On this point as well a requirement was omitted and the decision was left to the architects (1).

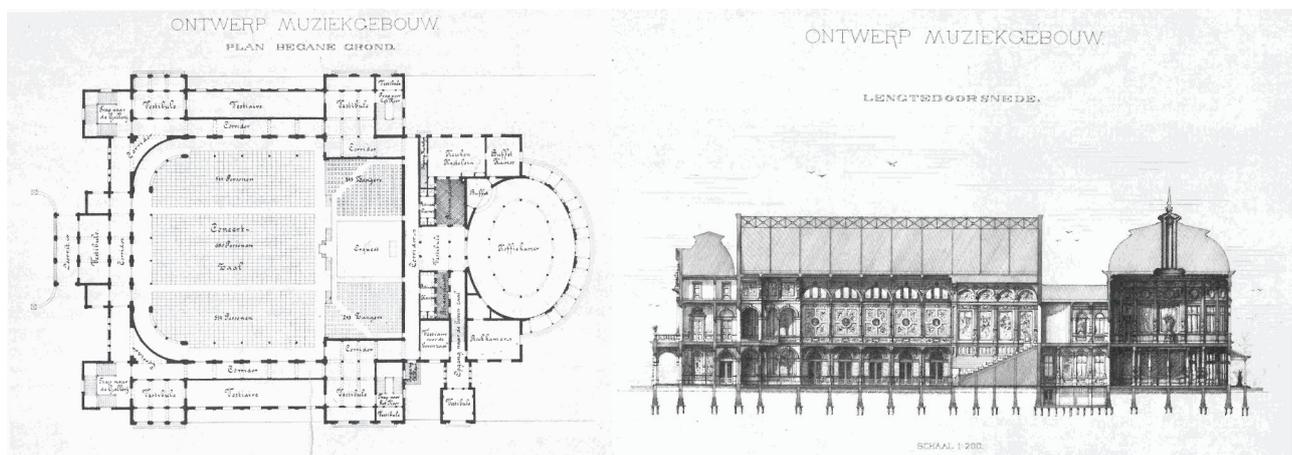
Figure 3. First contest design by Dolf van Gendt, October 1882. Left: plan, Right: longitudinal section

When the five contest designs were evaluated by the jury, it certainly had an opinion on the acoustics. The length and width of the plans were compared to three other shoebox type of halls: Düsseldorf (24x39m), Vienna (19x40m)(note: actually the length at the top is ca. 54 m) and the design of the Gewandhaus in Leipzig (21x42.5m). The main hall in the first design of Dolf van Gendt had dimensions (w_xl_xh) 35x42x15,5 m and the jury considered it too wide compared to its length. Another comment was about the flat ceiling, which was considered unfavourable for the acoustics.

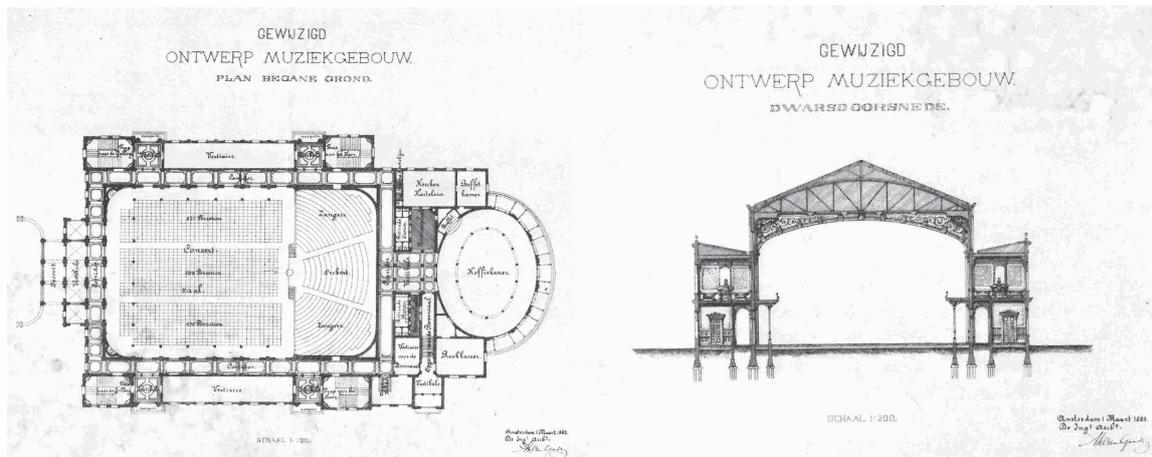
Figure 4. Modified contest design by Van Gendt, March 1883. Left: plan, Right: cross section

The adapted contest design was delivered in March 1883. Van Gendt had listened to the jury and made the hall smaller (27.8 m wide, 44 m long). In the first design the hall was wider than the stage, in the second design it was continuous. The stage setting was curved now and all four corners were rounded, following the general opinion that rounded corners prevent sound from getting stuck in the corners. The ceiling was raised to 17.5 m (according to the architect: “because this seemed necessary”, in the first design it was limited to control costs) and provided with almost square

cassettes. There were no comments on the acoustics of the hall by the jury, even though Van Gendt's adapted contest design was still wider than all three examples they had. Although the jury could not decide between the two architects, the board awarded the assignment to Van Gendt.

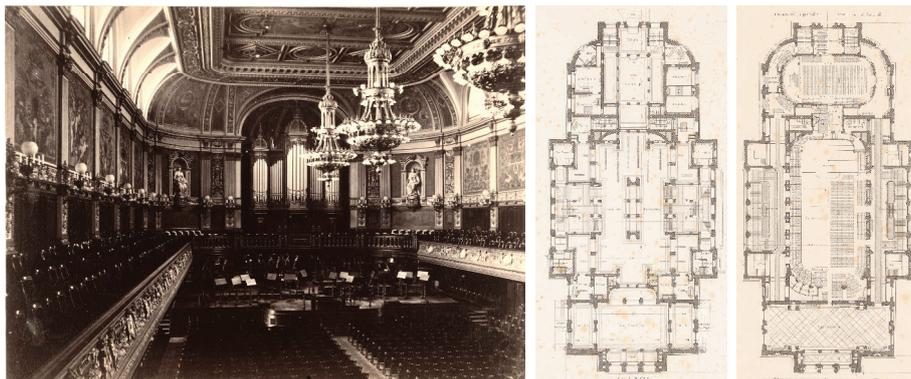
Figure 5. Neues Gewandhaus Leipzig (finished in 1884, Photo undated, plans published in 1886).

The Neues Gewandhaus in Leipzig was finished in 1884, so during the competition in Amsterdam in 1882, it was not completed yet. Nevertheless, the plan of Van Gendt has many similarities with Leipzig, which raises the question of whether the plans were known to Van Gendt. The small hall is rotated and positioned at the short end of the main hall. The ceiling is supported by a vault with roof dormers. It was considered beneficial for the acoustics to have other spaces surrounding the hall, so there were no outer walls (mentioned in the article by Thooft), which is the case for both halls.

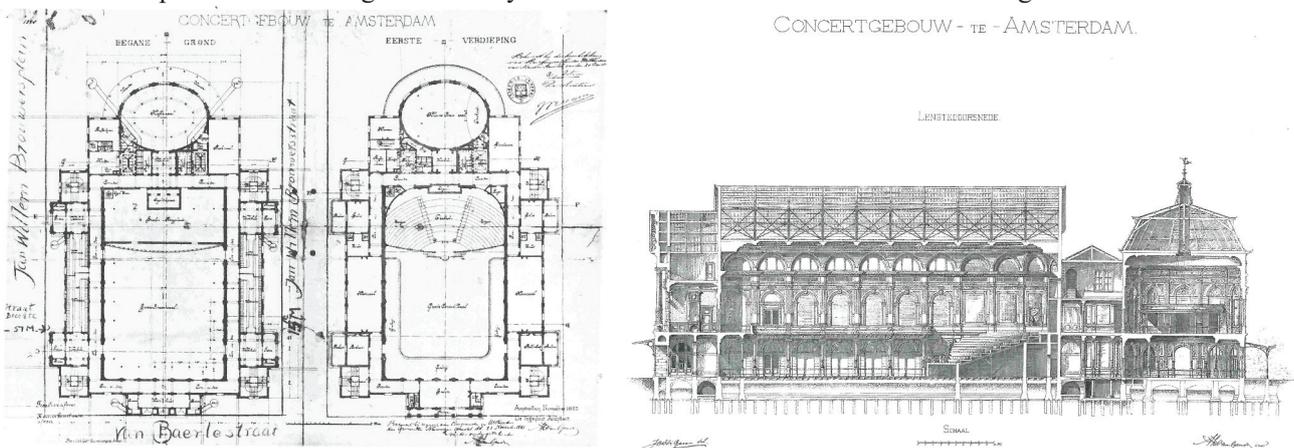
Figure 6. Final design, November 1883

There are other similarities as well: it was a private initiative and a combination of hall and orchestra. However, there is also an important difference: the hall in Leipzig is on the first floor. Shortly after the appointment of Van Gendt in April 1883, he was asked to consider lifting the hall to the first floor to be able to make foyer space and vestiaires on the ground floor. The foundation was considered too heavy for this and it did not fit the budget, so this idea was abandoned. In November 1883 a simplified final design was ready. The two rounded corners behind the stage remained.

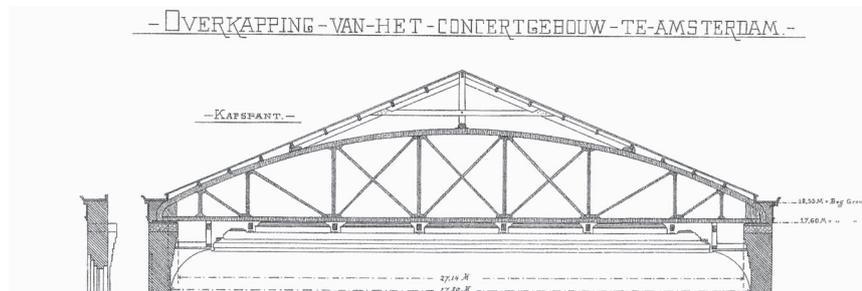
Figure 7, Steel construction for the roof and the ceiling. (published in October 1887)

The roof construction was made with steel trusses. The large span of 28 m was special and the drawings were published in a building magazine. The deflection was tested (5.5 mm with a load of 24 tons). The steel construction was made in Leuven, Belgium.

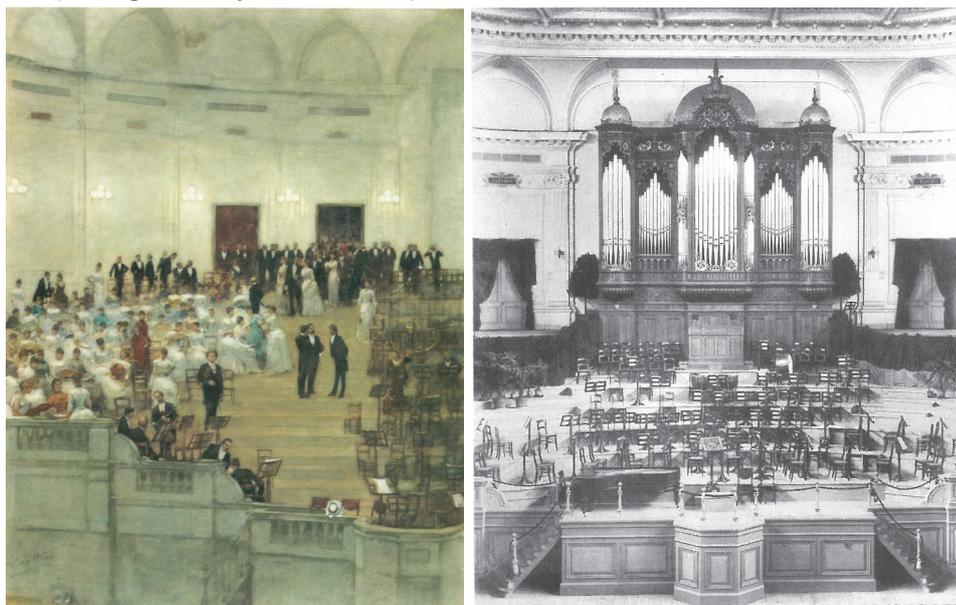
Figure 9. Left: Opening 11th of april 1888 (Aquarel N.van der Waay), Right: Photo of the interior in 1891 (with new organ), with screens, drapes and plants to help to control the acoustics.

Other early remedies included adding drapes (“portières”) at the entrance doors, building a low screen at the back of the orchestra, covered with thick drapes, and filling empty areas of the stage with potted plants, which it was hoped would “soak up the sound” (fig 9, right). Carpet was placed under the brass and percussion instruments. There was no sufficient budget for carpet along the corridors in the hall. Attendance at Concertgebouw Orchestra concerts continued to be poor, for a large part because of poor access roads. Only a few special performances drew a full audience. Financial difficulties were so severe at this time that the institution barely survived, and indeed in 1891 the orchestra’s contract was for a time dissolved.

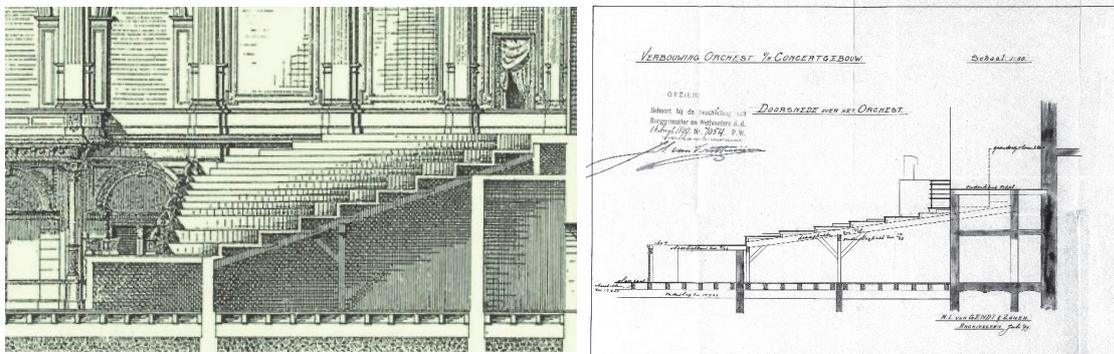
Figure 10. Section of the stage before (left) and after the renovation in 1899 (right).

It was soon discovered that the hall's balance problems had not been solved by Mengelberg and the Pathétique. In 1899 Mengelberg took the initiative to rebuild the stage. The board was not enthusiastic from the start, not only because of the costs but also because it could turn out to be counterproductive. Together with Van Gendt the stage was redesigned. It was reduced in height 20 cm at the front, 1.2 m at the sides, and 2.3 m at the rear and stairs were introduced next to the organ. The works were done in the summer, while concerts were given in the garden. The new stage not only reduced the excessive vertical spacing between the orchestra sections, but also provided a wider area for musicians at the front of the platform and exposed reflective surfaces at the rear. When the hall reopened on 11 September 1899, the balance between the sections was vastly improved. It was declared in the *Nieuws van den Dag* (12 September 1899) that the impression was very good and "all the necessities for world renown were now present".
