Stage Acoustics: Renovation of the concert hall de Doelen, Rotterdam and other stages

Margriet R. Lautenbach (1), Martijn L.S. Vercammen (2)

PACS: 43.55.Fw Auditorium and enclosure design

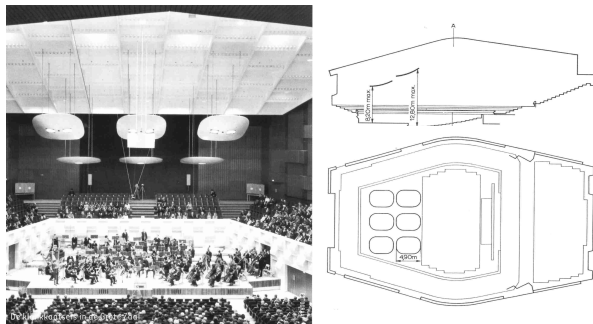
When opened in 1966, the main concert hall in De Doelen, was fitted with six canopies above the stage platform [2,3], see figure 1. Their function was twofold:

Figure 1. De Doelen 1966, photo, vertical and horizontal section

By means of a 1:10 scale model and a computer model (CATT-Acoustic) the influence of the proposed reflector as well as the influence of the original (1966) reflector is investigated. The original stage reflector consisted of six canopies and the front three were (according to pictures and drawings from then) quite tilted, and therefore primarily reflecting to the audience and as such not back to the stage (see also figure 1).

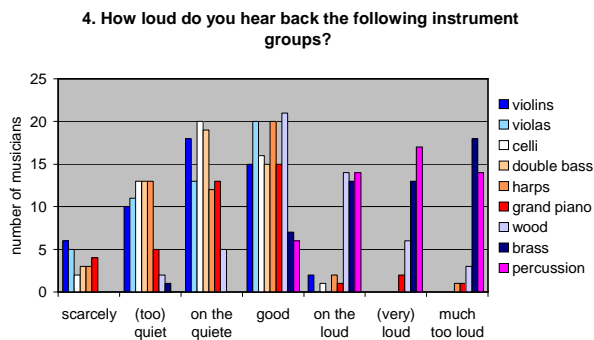
The questionnaire was anonymous, but the musicians were asked to specify his or her instrument so the answers can be related to a position on stage. To compare the subjective opinions with acoustic parameters, the answers were given a score from minus 3 to plus 3 in the data processing. Figure 2 gives an example of the output

Figure 2. Example of the questionnaire output for ensemble conditions before renovation.

The musicians have expressed themselves as very positive towards the acoustic changes of the renovation. According to their opinion the ensemble conditions have improved significantly. Although the number of musicians that was enthusiastic about filling in another questionnaire was clearly less than before the renovation, the opinion on the ensemble conditions was much better, as can be seen from a comparison of figure 9 to figure 2.

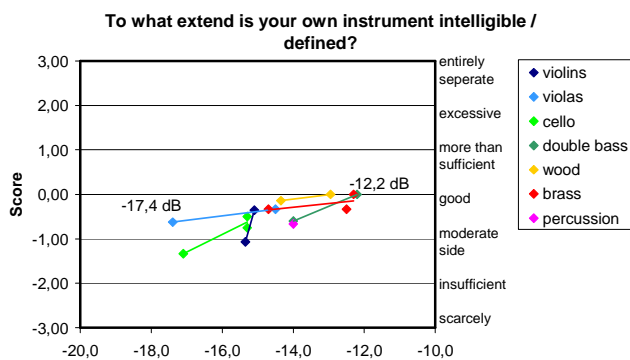
When the measured ST1's of the two stages are compared to the musicians opinions in one graph, a clear trend can be observed: a higher value for ST1 gives in general a higher score for loudness and intelligibility, See figure 3.

Figure 3. Overview comparison measured ST1 values in De Singel and De Doelen to the results of the Questionnaires.

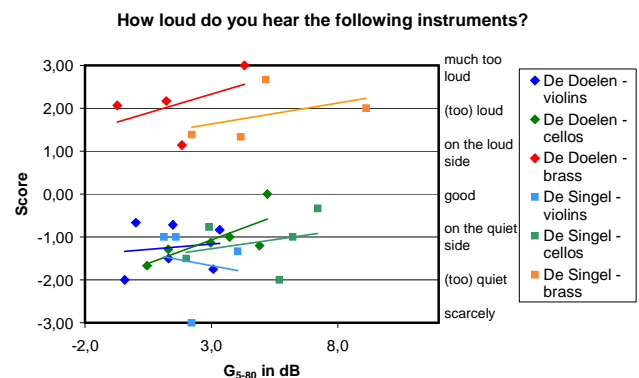
for individual instrument groups. But when asked "how loud do you hear a particular instrument group", a higher value relates quite well to a higher G_{5-80} , see figure 4.

Figure 4. Comparison of G_{5-80} to the musician's opinion

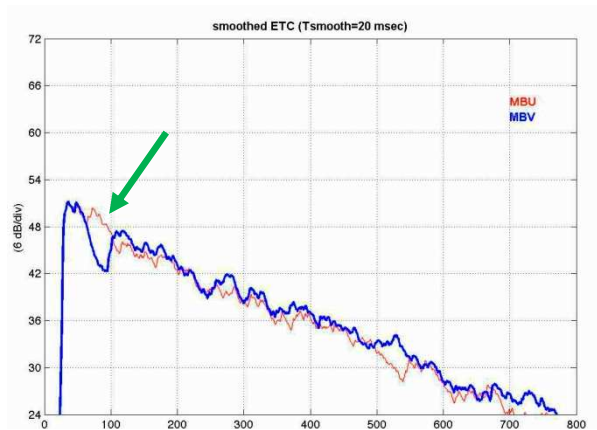
Figure 5. Scale model impulse responses with stage reflector (red) and without (blue), measured from B1 (cellos) to M2 (trumpets)

The stage reflector clearly fills the gap between the early reflections from the existing stage enclosure and the ceiling, which is marked by the green arrow. Within the own instrument groups (B1-M1 and B2-M2) the ST1 increases with 0.4 and 0.7 dB respectively at positions at the front of the stage. For a position more in the middle an increase was found of 1.7 dB.

Figure 6 gives a photo of the scale model from behind the investigated stage reflector. Figure 7 gives the measured impulse responses from B1 to M2 and from B2 to M1.

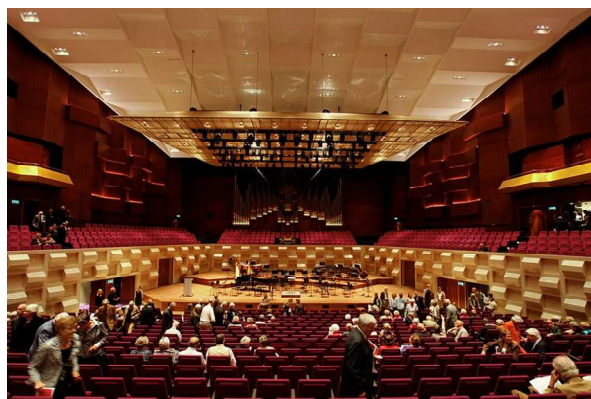
Figure 7. Overview of De Doelen after renovation

Just before the official opening of the hall, measurements were performed in the hall. The measured support ST1 at the front of the stage is enhanced from -17 dB before renovation to -15 dB after the renovation with canopy. The the early reflections strength (G_{5-80}) at the different positions is enhanced with 1 to 3 dB (averaged +1.5 dB), as can be seen from figure 8.

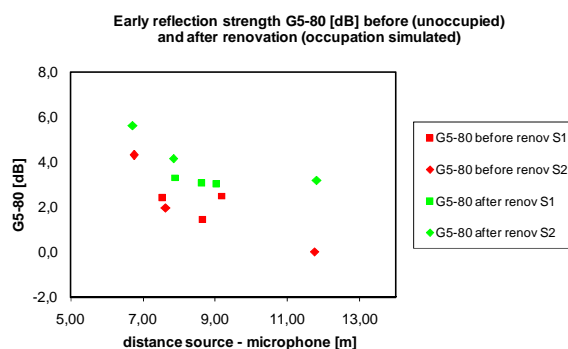
Figure 8. Measured G_{5-80} on stage in before renovation (2008, red), and after renovation (2009, green)

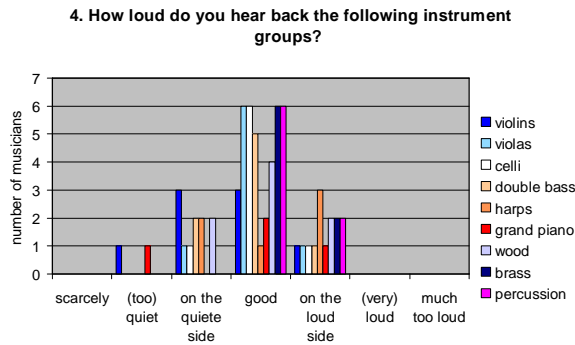
Figure 9. Example of the questionnaire output for ensemble conditions after renovation.

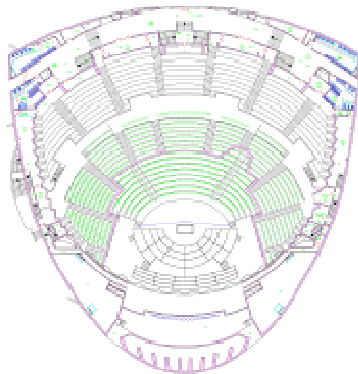
The Maurice Ravel is quite a large concert hall, and especially very wide (59m), with a arena like public seating arrangement, see also figure 10. The stage is very large (425 m²) and although the ceiling above the stage is rather low (12 m) the measured impulse responses on stage show a significant gap between the direct sound and the important early reflections, see also figure 11.

Figure 10. Plan of the Maurice Ravel Concert Hall, Lyon.

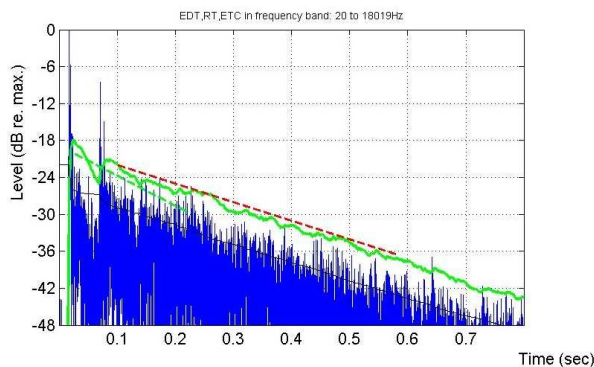
Figure 11. Measured (squared) Impulse Response Maurice Ravel on stage from B1 (cello) to M17 (conductor), with a significant gap between direct sound and “early” reflections

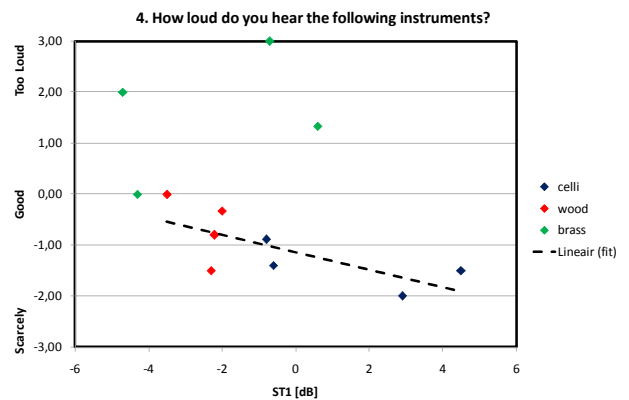
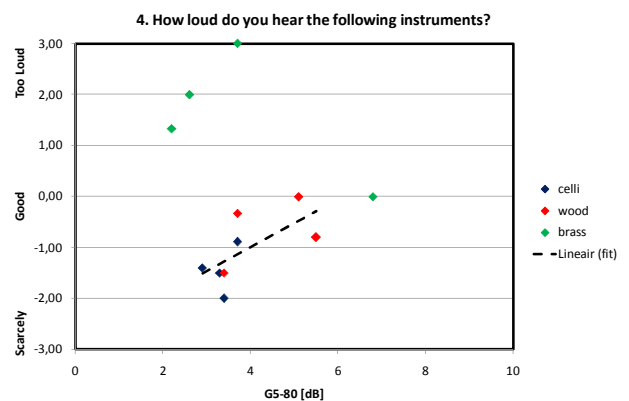
When comparing the musicians opinion on the ensemble conditions to the measurement results, also in this case only a correlation was found for the early reflections strength (G_{5-80}). Figures 11A and 11B give an example of the comparison of the musicians judgement and the ST1 and the G_{5-80} (it is noted that the ST1 is meant for the musician’s perception on the loudness of their own instrument and not for ensemble conditions, but it gives a good starting point to think about these matters).

In this case the musicians were asked how loud they can hear the other instrument groups. The answers are averaged over the musicians of a certain instrument group. The graphs show the musicians judgement versus the measured parameter derived from the impulse response between those instrument groups of source and receiver. As for the brass, a correlation is hard to find for both ST1 and G_{5-80} , it is simply (too) loud. For cello and woodwind, a linear fit can be made. The linear fit of the ST1 is initially the opposite of what is to be expected: a higher ST1 between instrument groups leads to a lower judged loudness. In case of the G_{5-80} the result is more in the line of expectations, as a higher G_{5-80} leads to a higher judged loudness

Figures 11A and B. Comparison between musicians judgement (y-axis) to the measured parameter (x-axis). Above: perceived loudness of cello and wood compared to ST1 (brass excluded from fitting), below: idem compared to G_{5-80}
