# The renovation of De Doelen Concert Hall

M.Vercammen<sup>1</sup>, M. Lautenbach<sup>2</sup>

<sup>1</sup> Peutz bv, Mook, The Netherlands, Email:m.vercammen@mook.peutz.nl

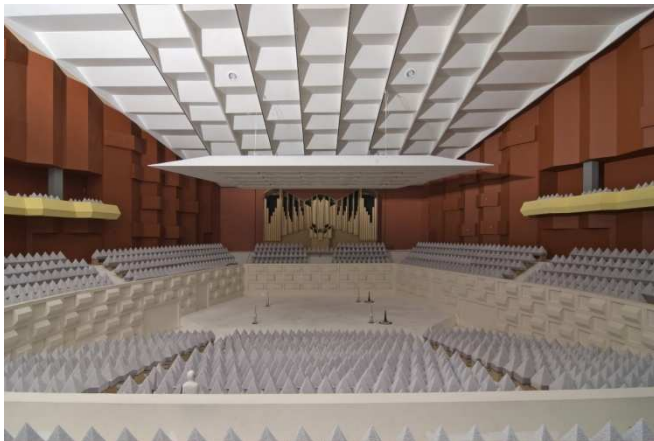
**Figure 8:** Picture of the 1:10 scale model of De Doelen with the new suspended technical ceiling above stage. In this ceiling the reflectors and lighting is integrated.

The scale model is made scale 1:10. The material is mainly mdf, painted to reduce high frequency absorption. The ceiling is made of 2 mm hard Polystyrene. The audience is made from foam material and placed on wooden strips. The measurements are done with special high frequency omnidirectional sources and 1/8” microphones to be able to

A stage reflector is proposed to improve the support at the front of the stage and the ensemble conditions. The stage reflector is positioned at a height of 10.5 m above the front of the stage and has slightly curved panels for diffusive reflections back to the stage.

Figure 8 gives a picture of the scale model with the reflector. The flat edges will be made acoustically transparent. The theatre lighting will be integrated in this suspended technical ceiling. Several configurations of the reflecting panels were tested, mainly to limit the influence of the reflector in the audience area.

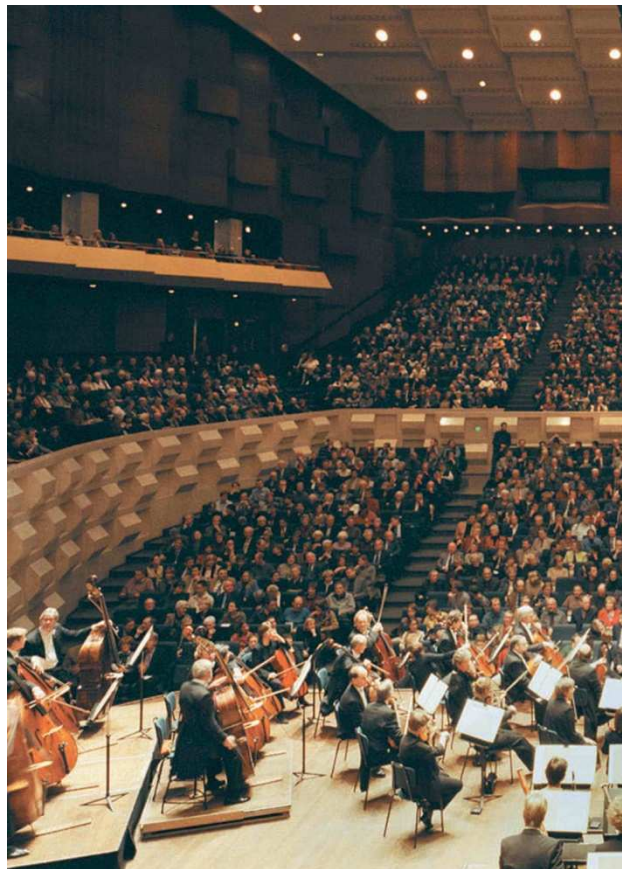
**Figure 12:** Picture of De Doelen

This 'marble' (actually it is travertine) wall with its sound diffusing blocks is very characteristic for De Doelen (fig.12).
